Otterdale
Road
Drainage
Improvement
Project

ASHE Old Dominion Section Meeting

Nate Mathis, PE, Chesterfield County

Alice Ortman, PE, JMT

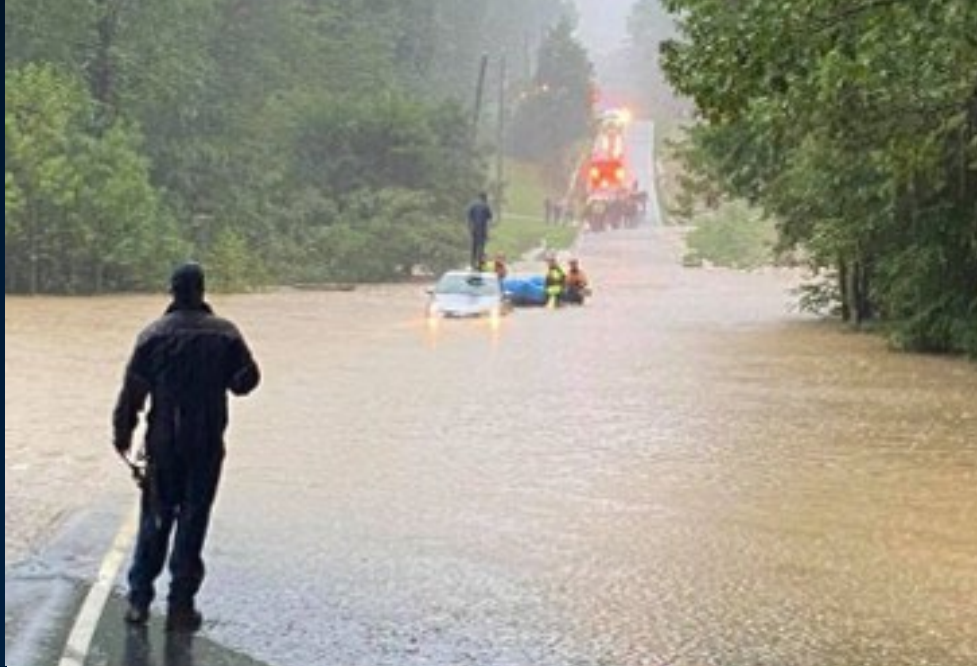
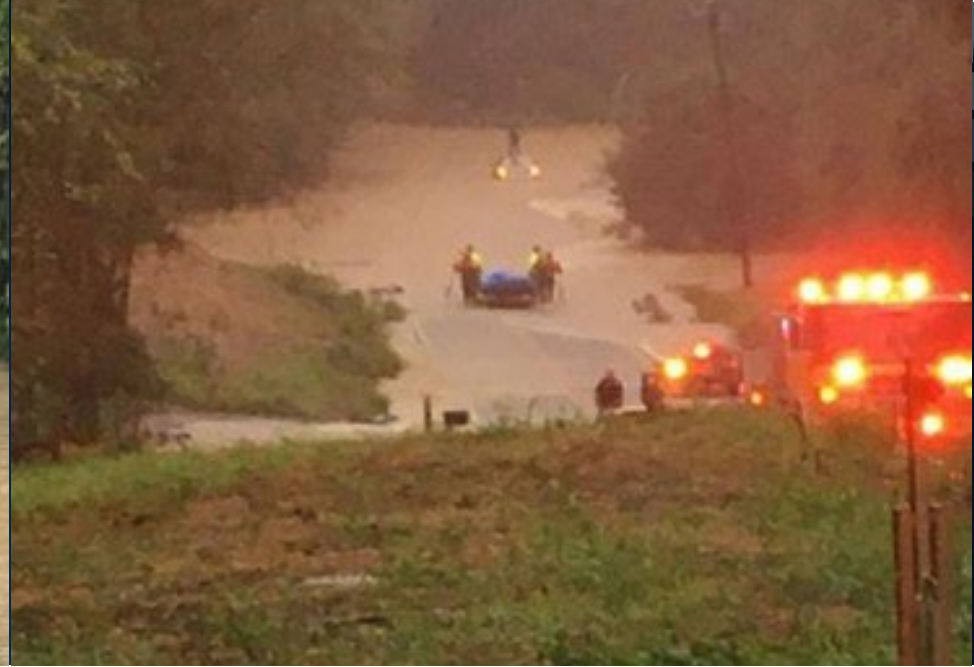
OTTERDALE ROAD FLOODING

In the last 5 years on record:

- Horsepen Creek crossing overtopped 13 times
- Blackman Creek crossing overtopped 15 times
- Otterdale Branch crossing overtopped 2 times

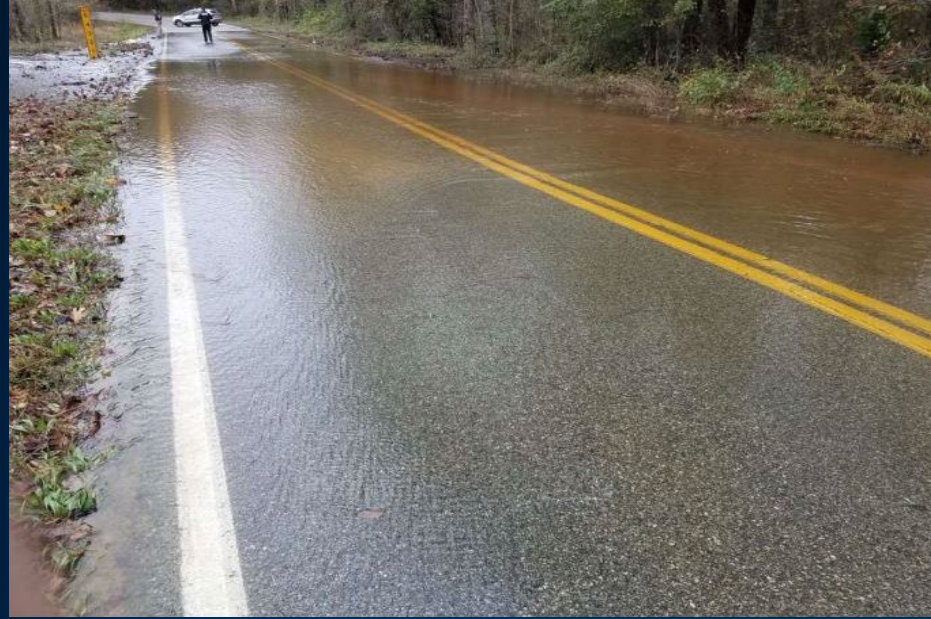
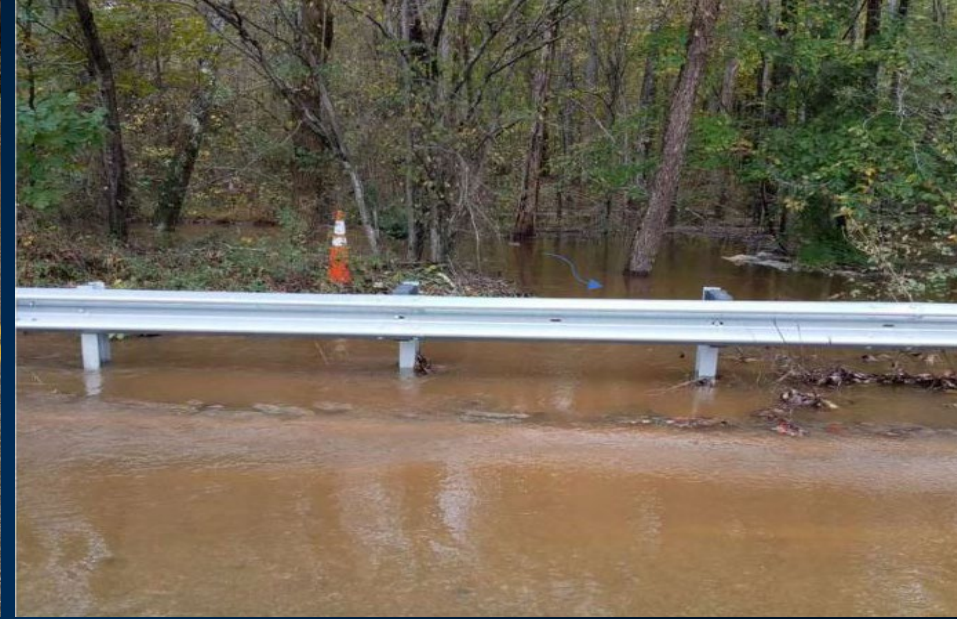
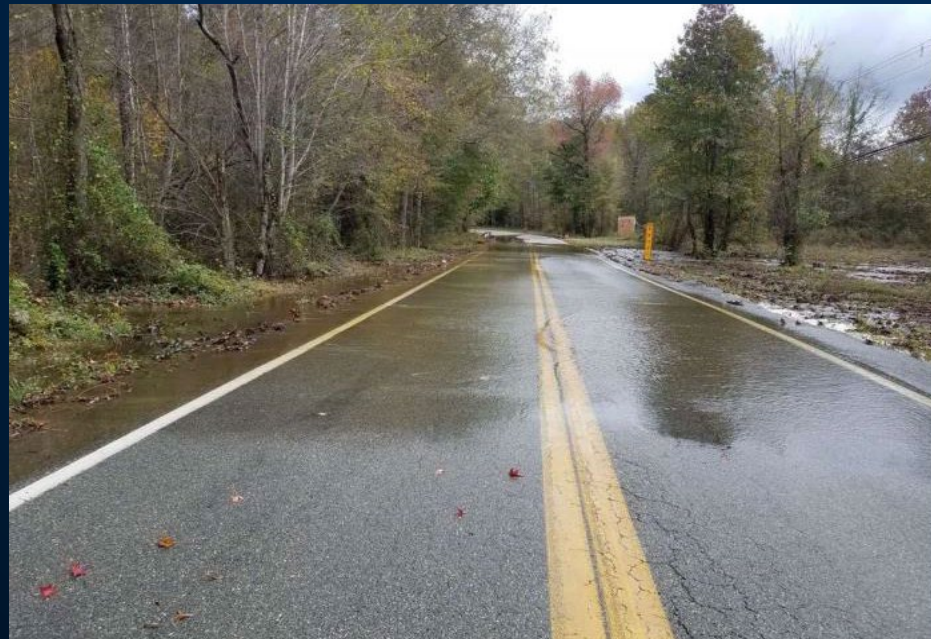
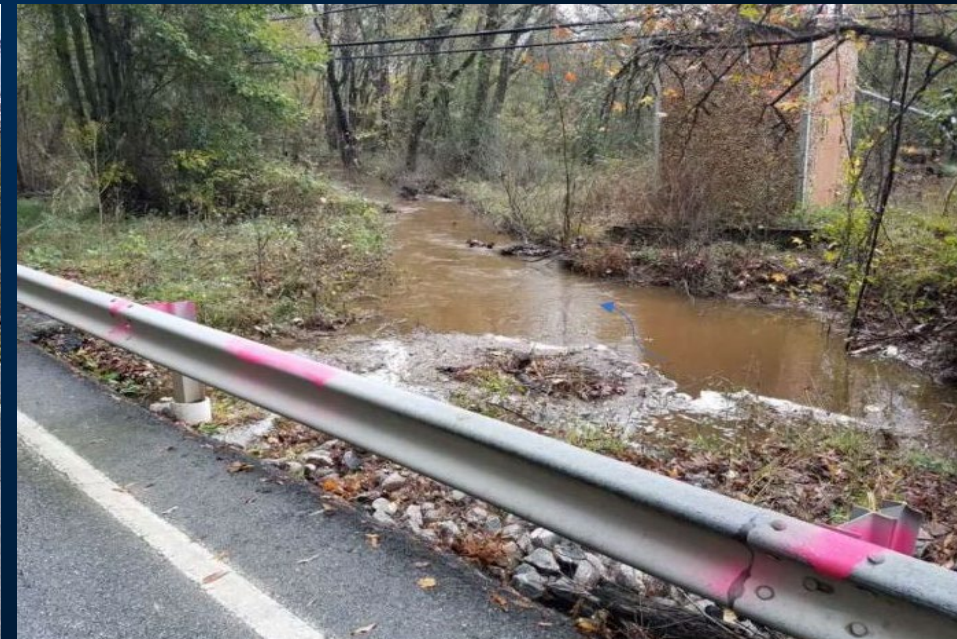
Horsepen Creek Crossing

- Existing double 3.75 ft X 2.42 ft elliptical pipes
- 35° skewed crossing
- Culverts completely submerged - at least 80% clogged
- Low road, overtopped by 10-year Storm by 1 ft to 1.5 ft
- Recently cleaned out and channel grading performed

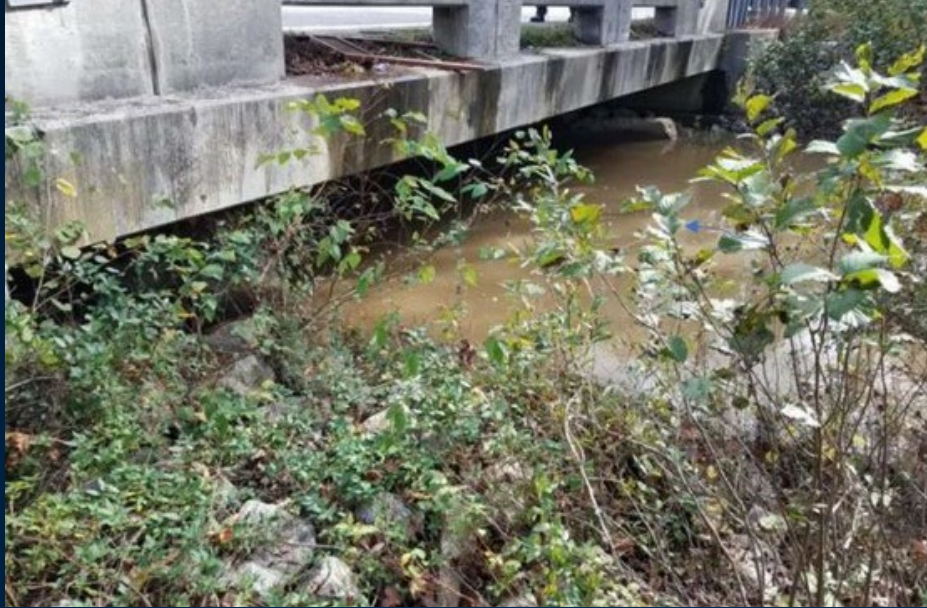
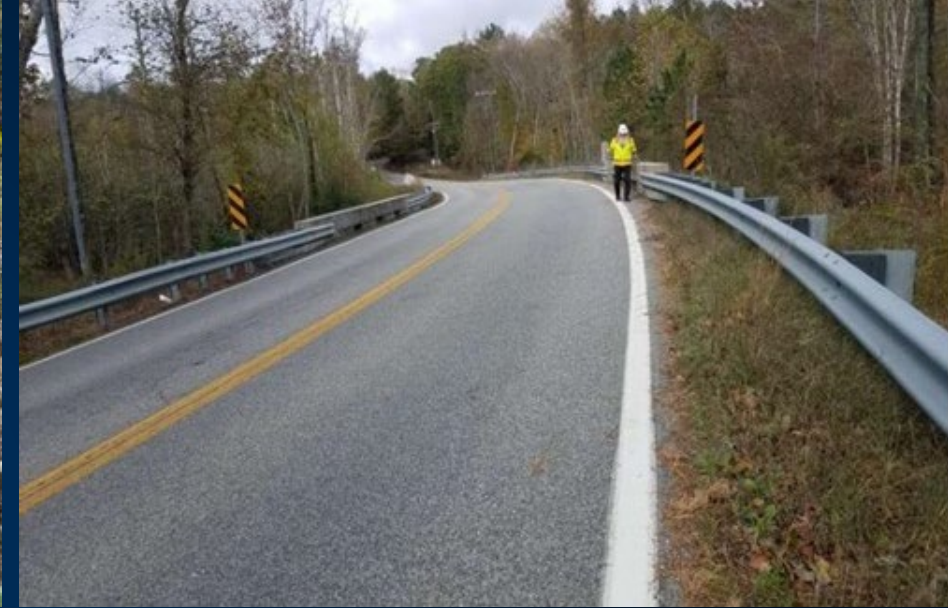
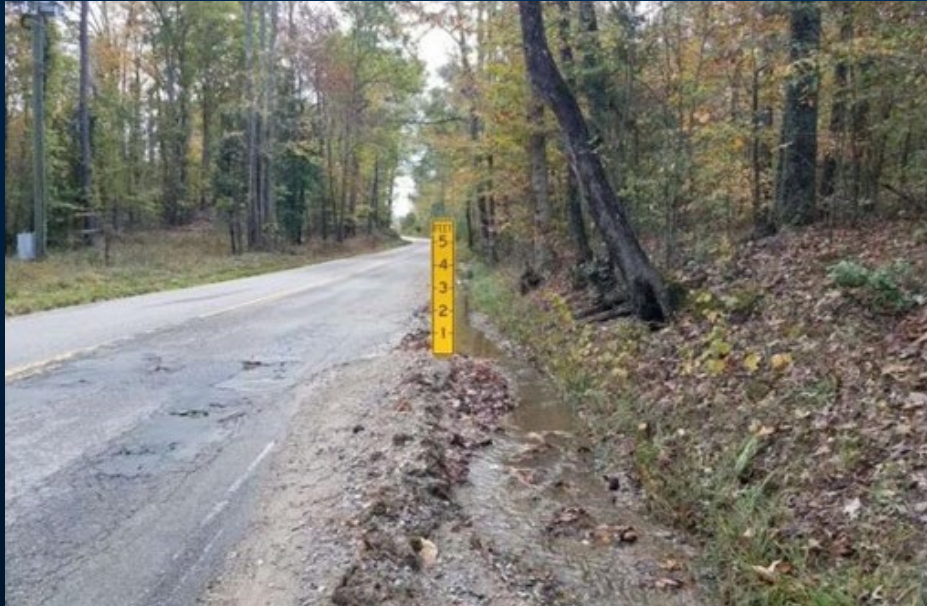
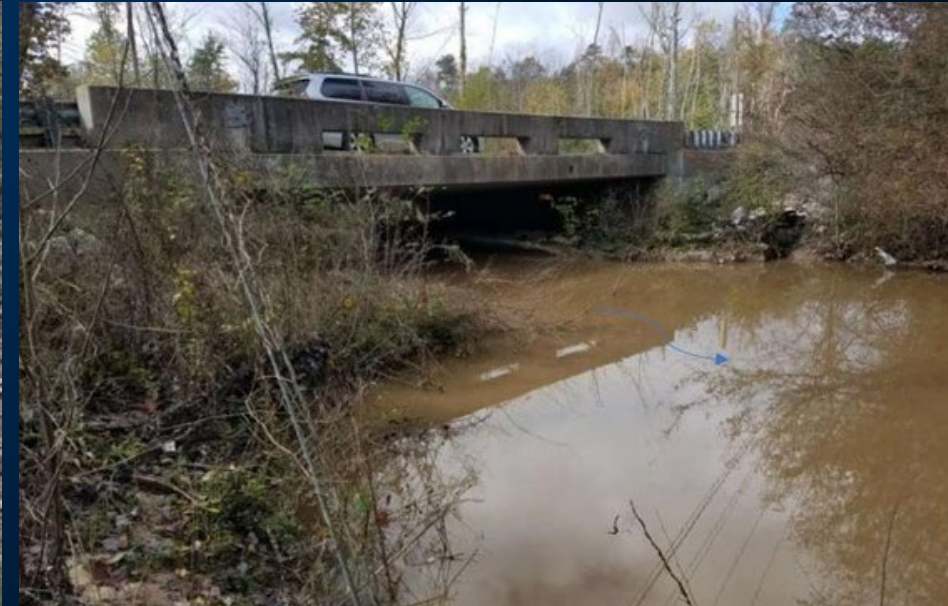
Blackman Creek Crossing

- Existing single span prestressed concrete slab bridge
- Pre-existing bridge footings in place—sheet piling
- Significant superelevation—8%
- Low roadway approaches, overtopped by 10-year Storm by over 2 ft

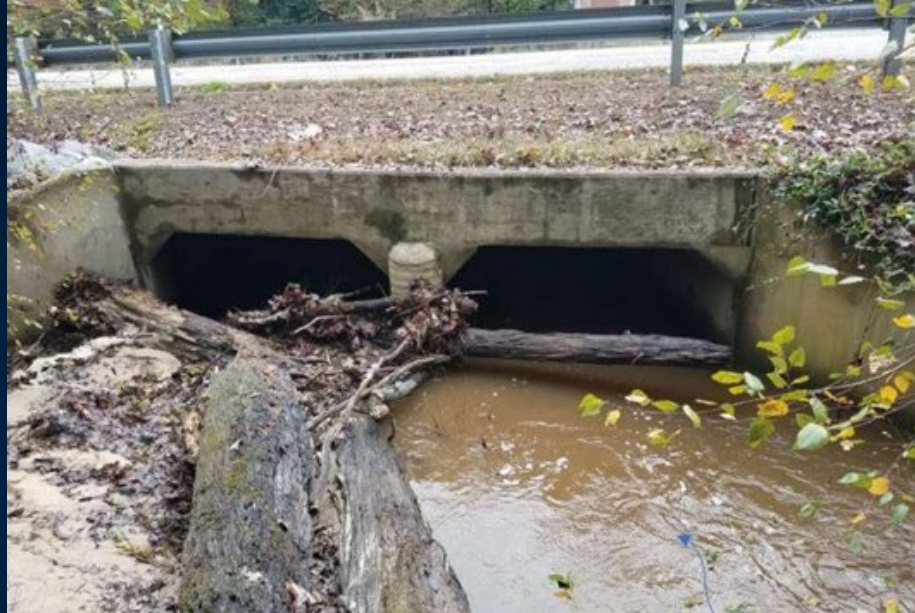
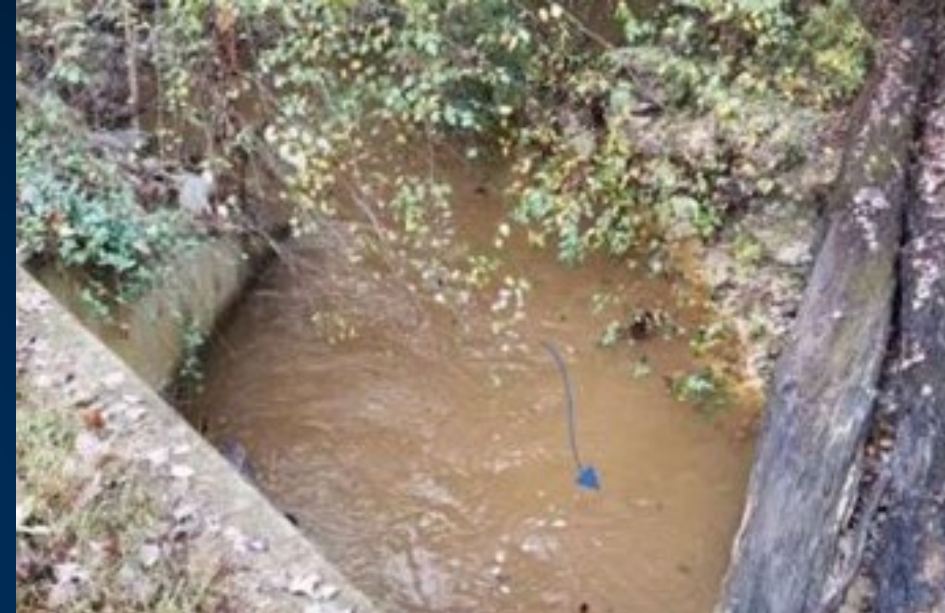
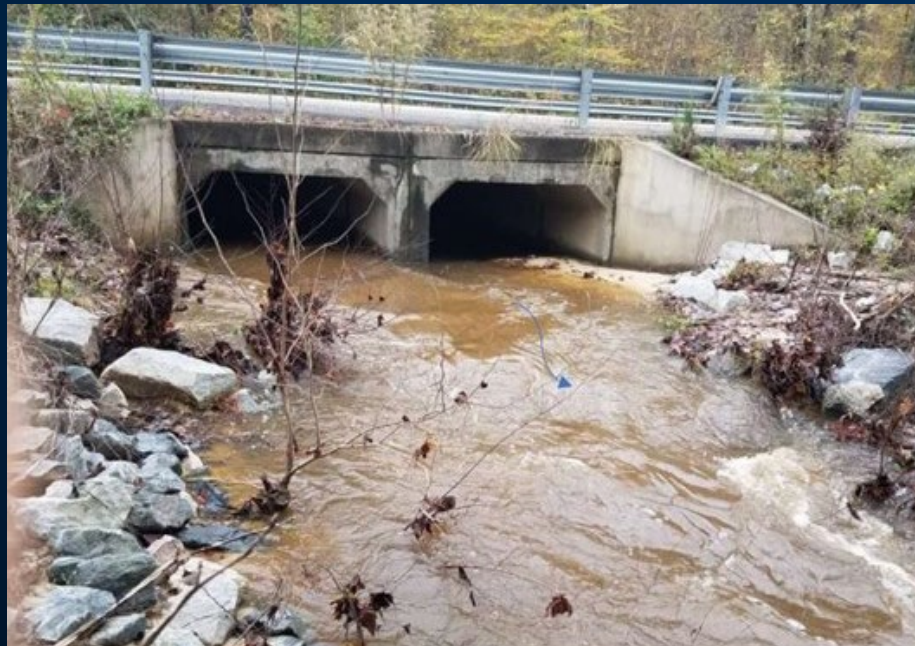
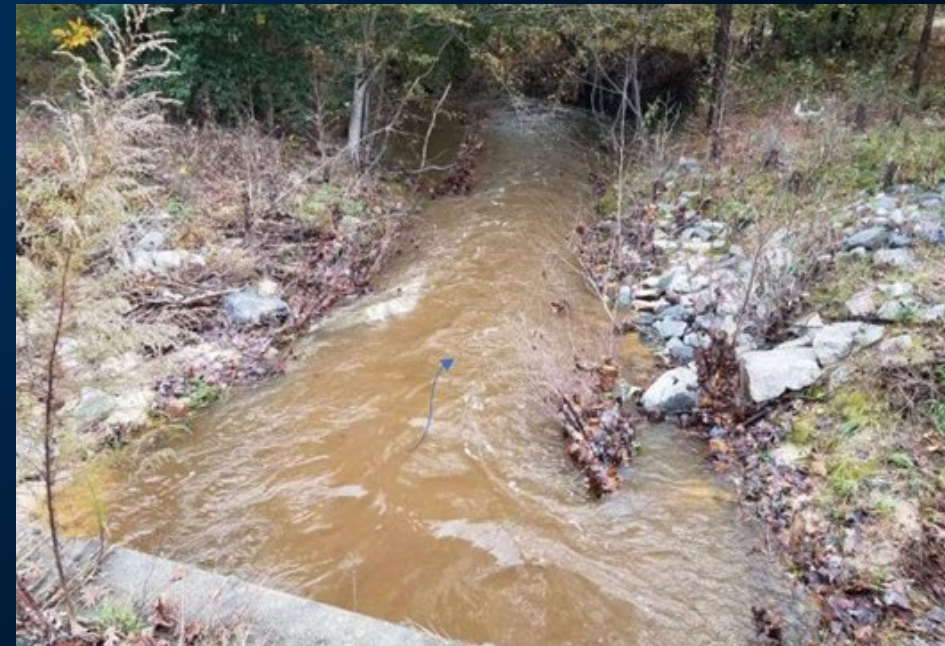
Otterdale Branch Crossing

- Existing double 7 ft X 6 ft concrete box culvert
- 68° skewed crossing
- Culverts completely submerged—at least 80% clogged
- Low road, overtopped by 10-year Storm by 1.7 ft

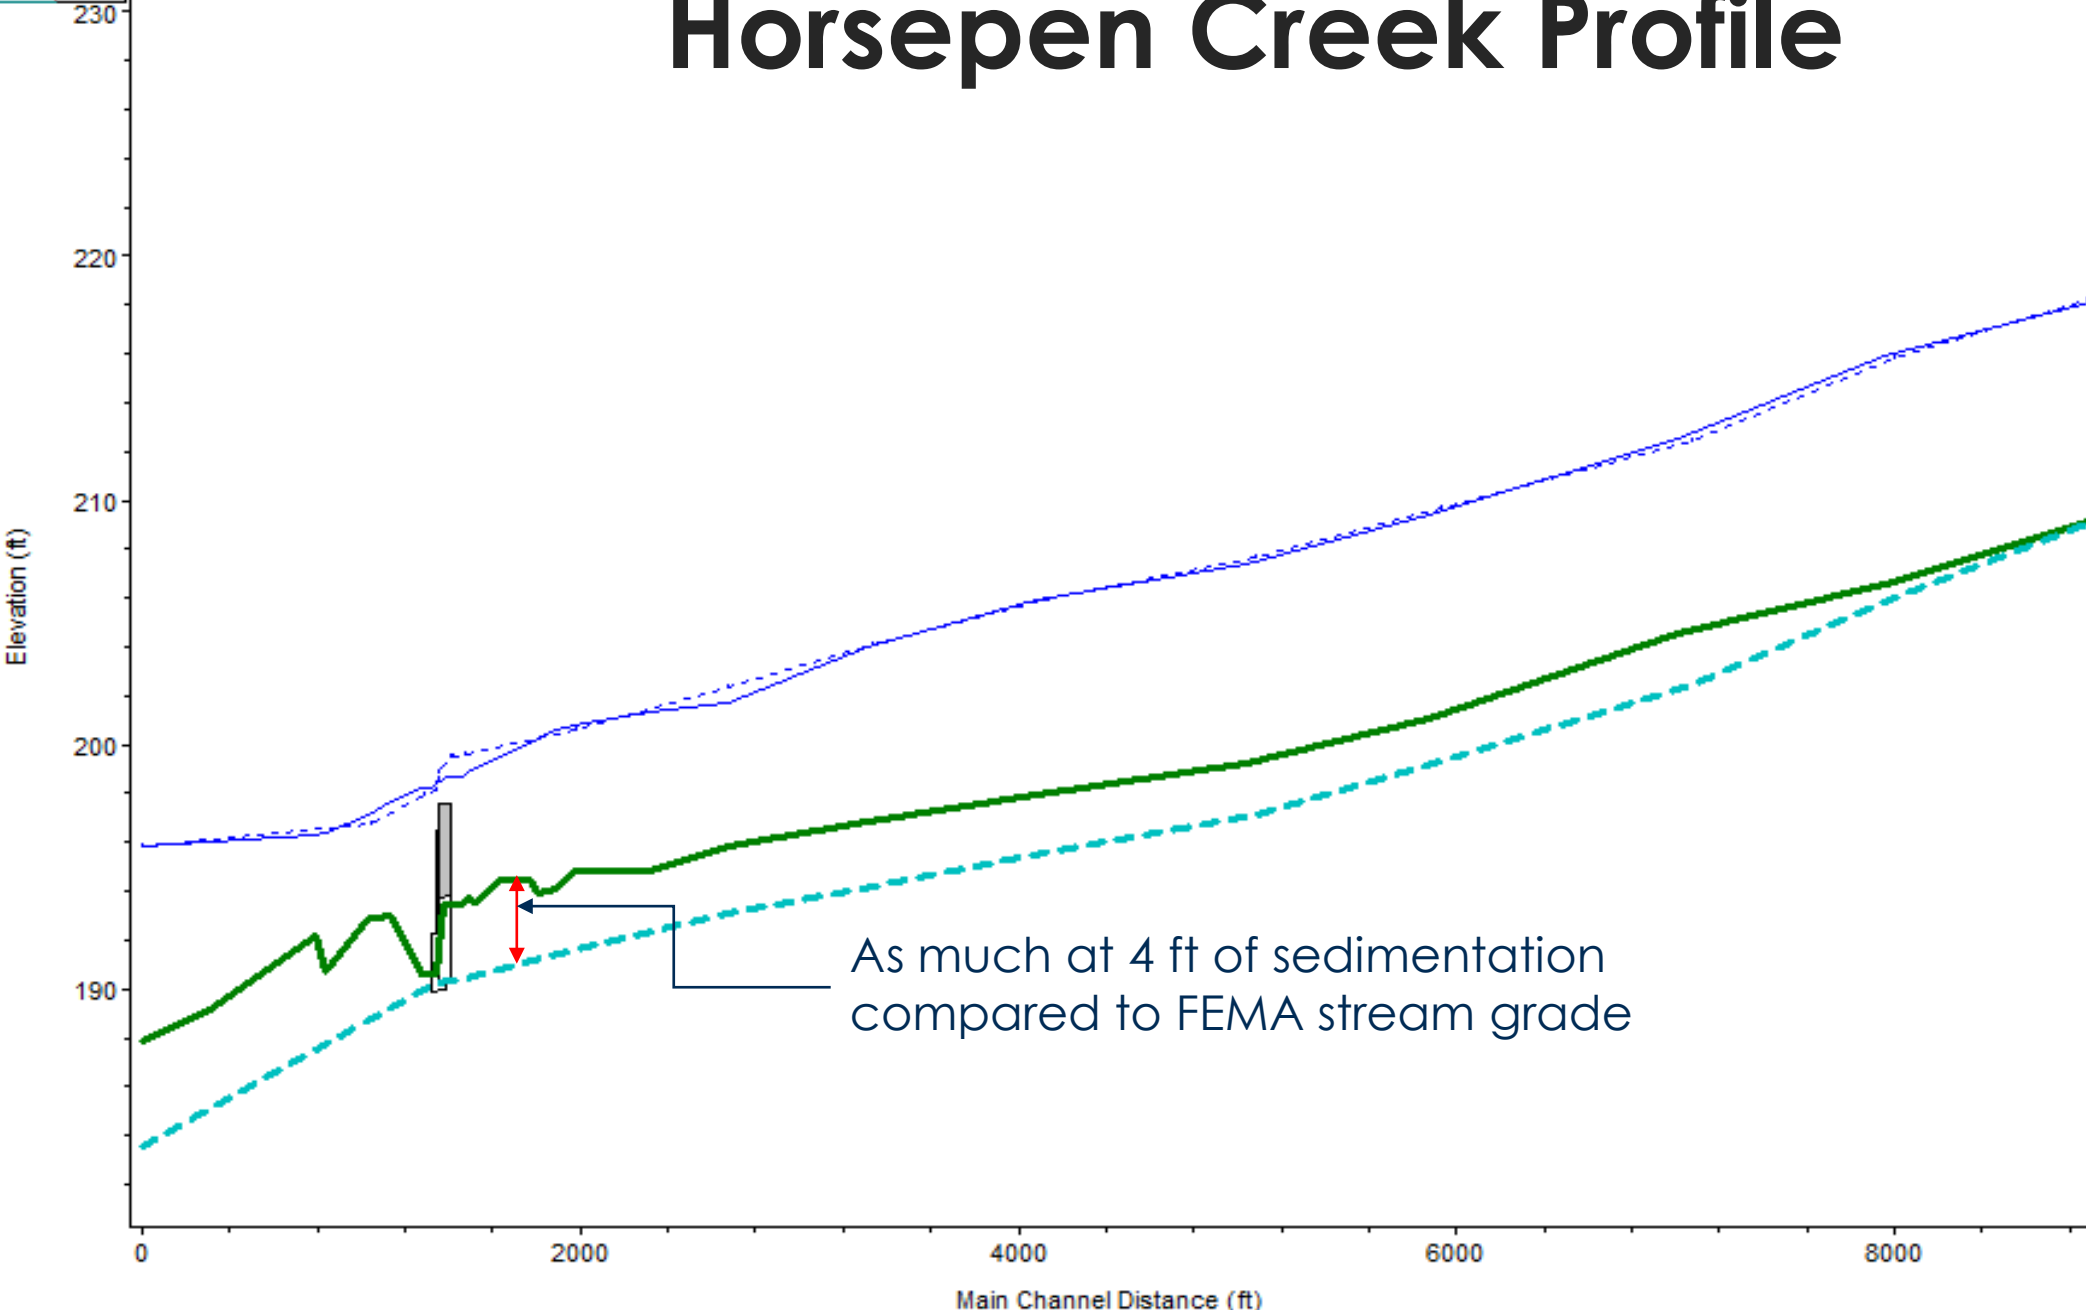
Horsepen Creek Profile

Legend	
	WS 100-YR - Survey
	WS 100-YR - FEMA
	Survey Ground
	FEMA Ground

As much at 4 ft of sedimentation compared to FEMA stream grade

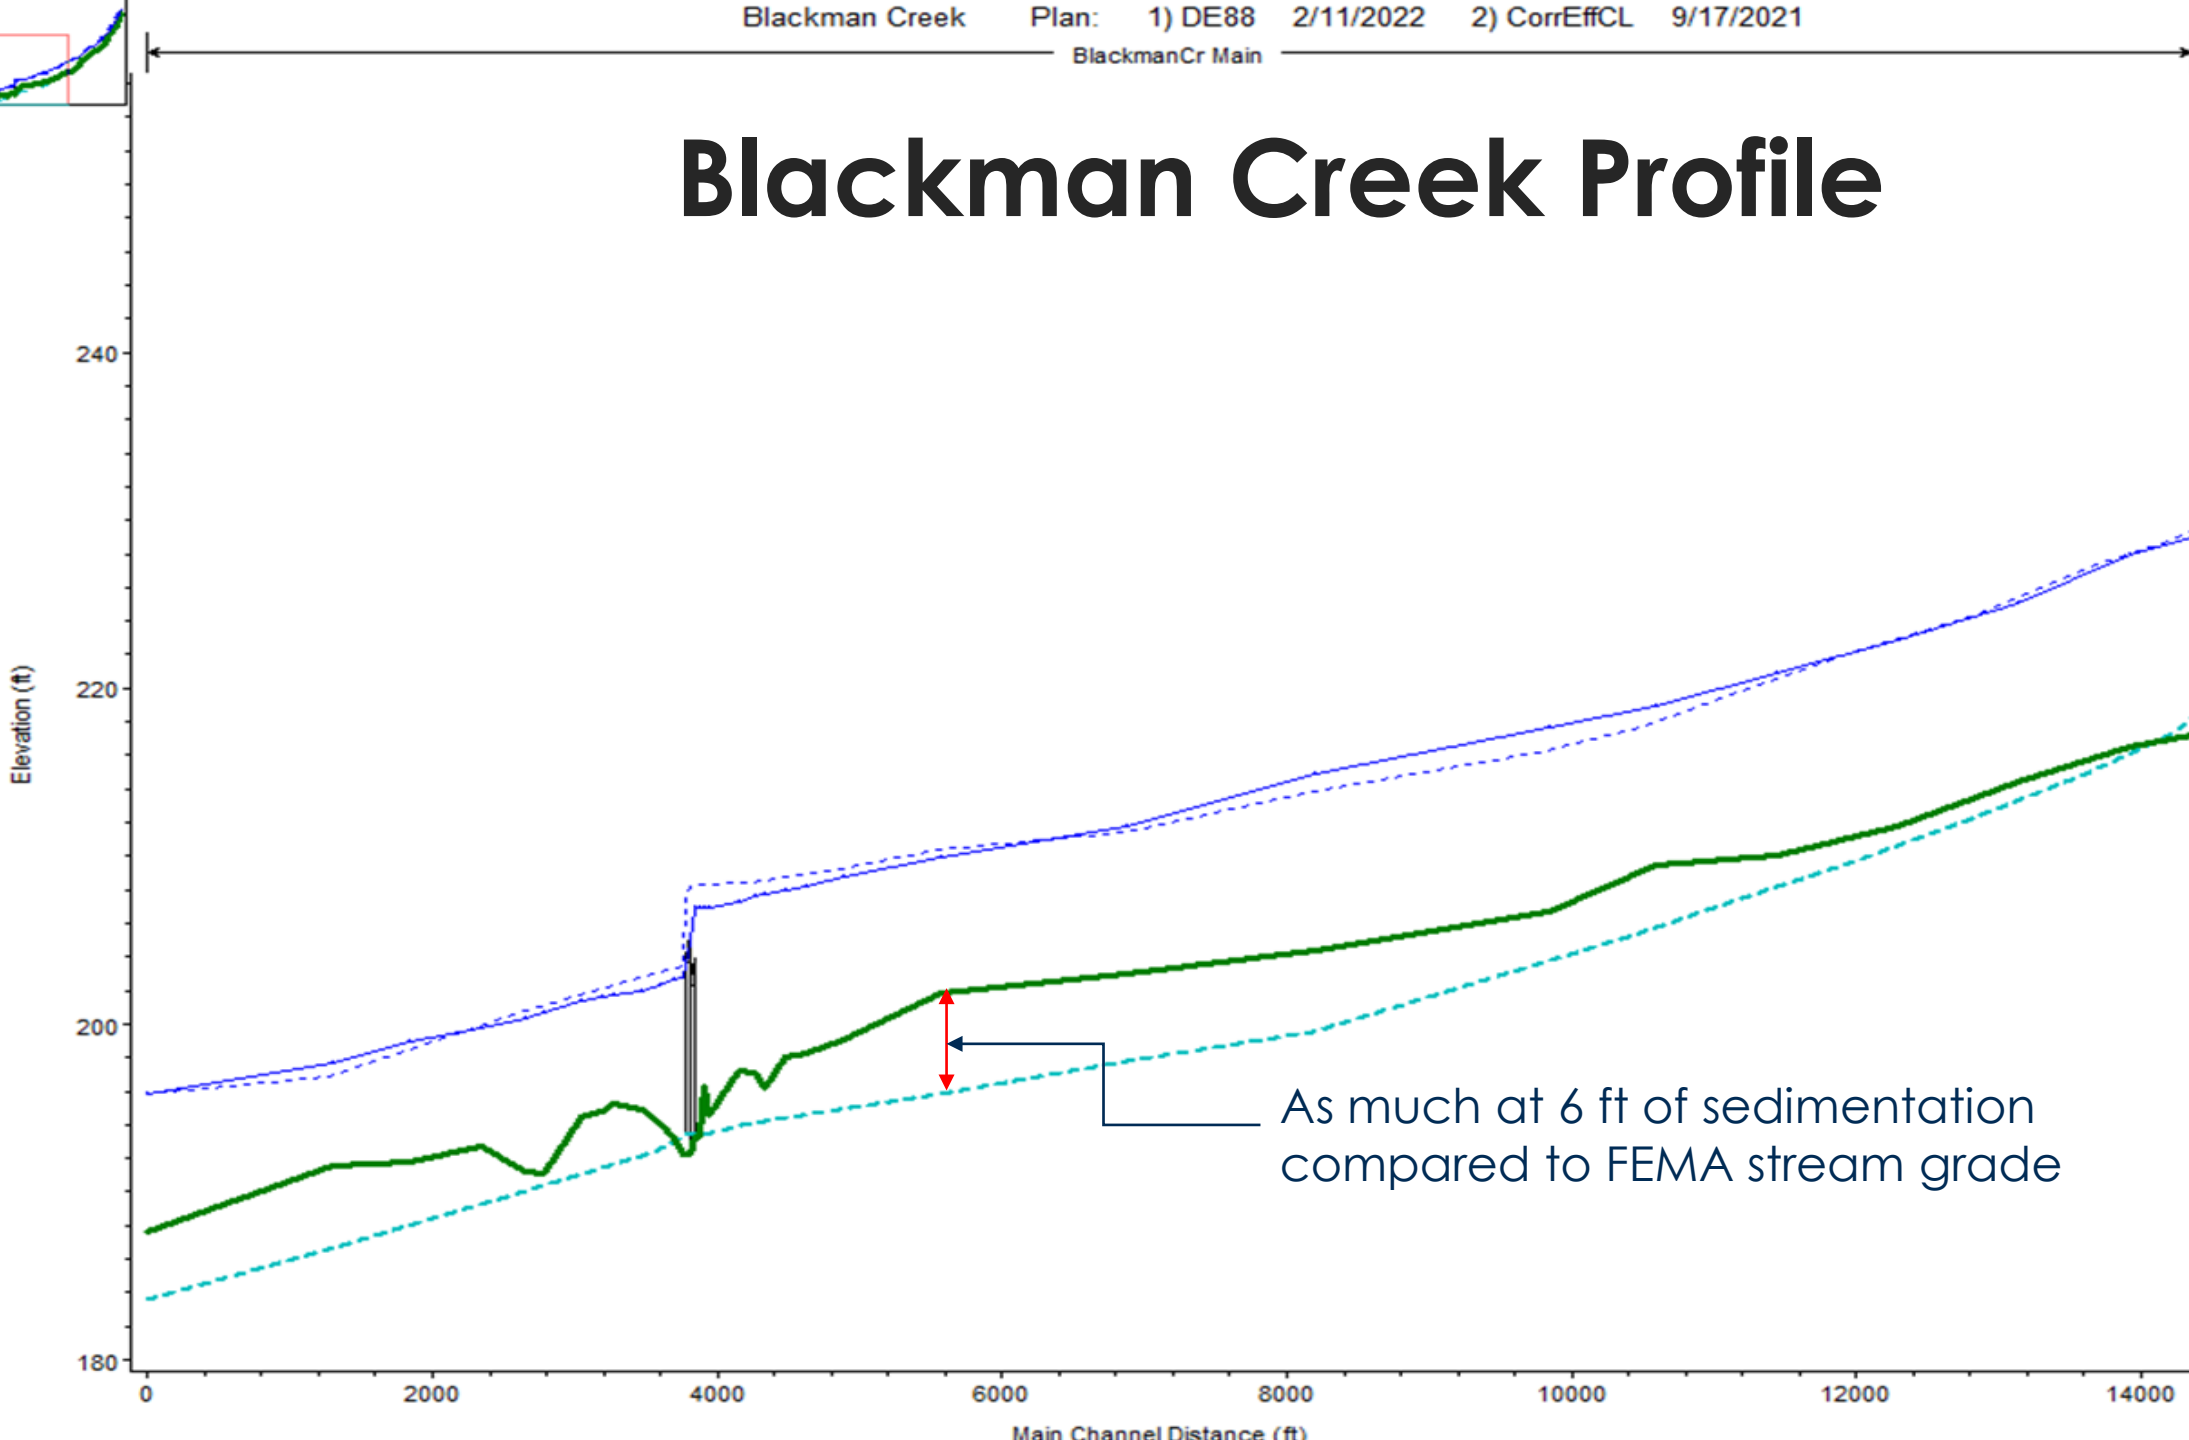
Blackman Creek Profile

Legend	
WS 100-YEAR - FEMA	
WS 100-YEAR - Survey	
FEMA Ground	
Survey Ground

As much as 6 ft of sedimentation compared to FEMA stream grade

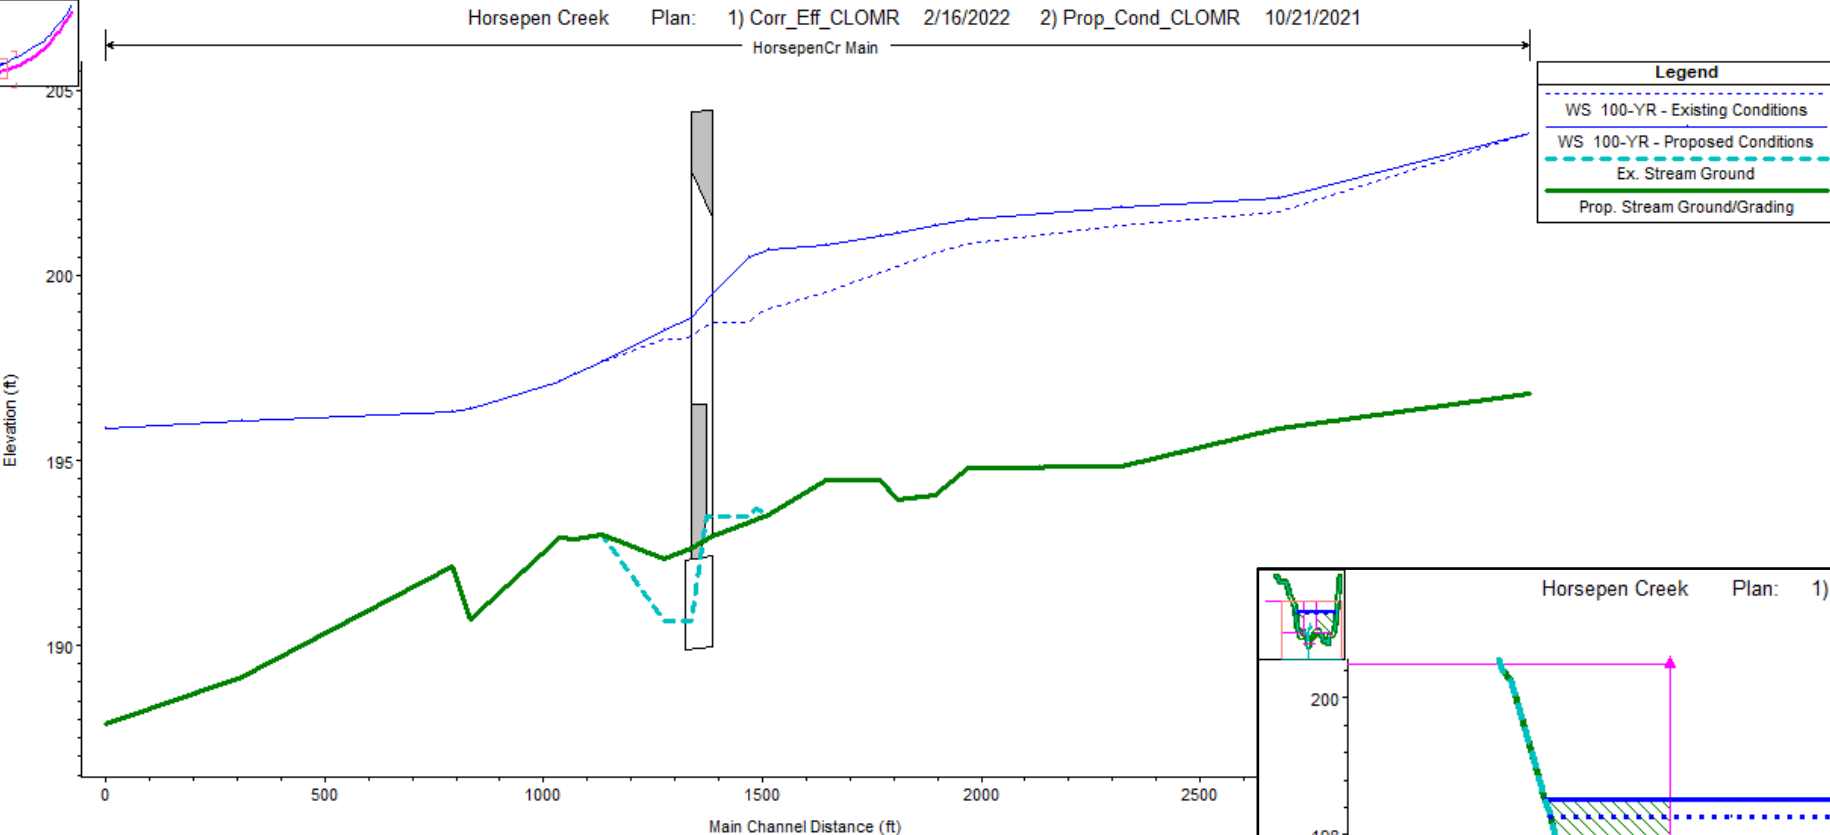
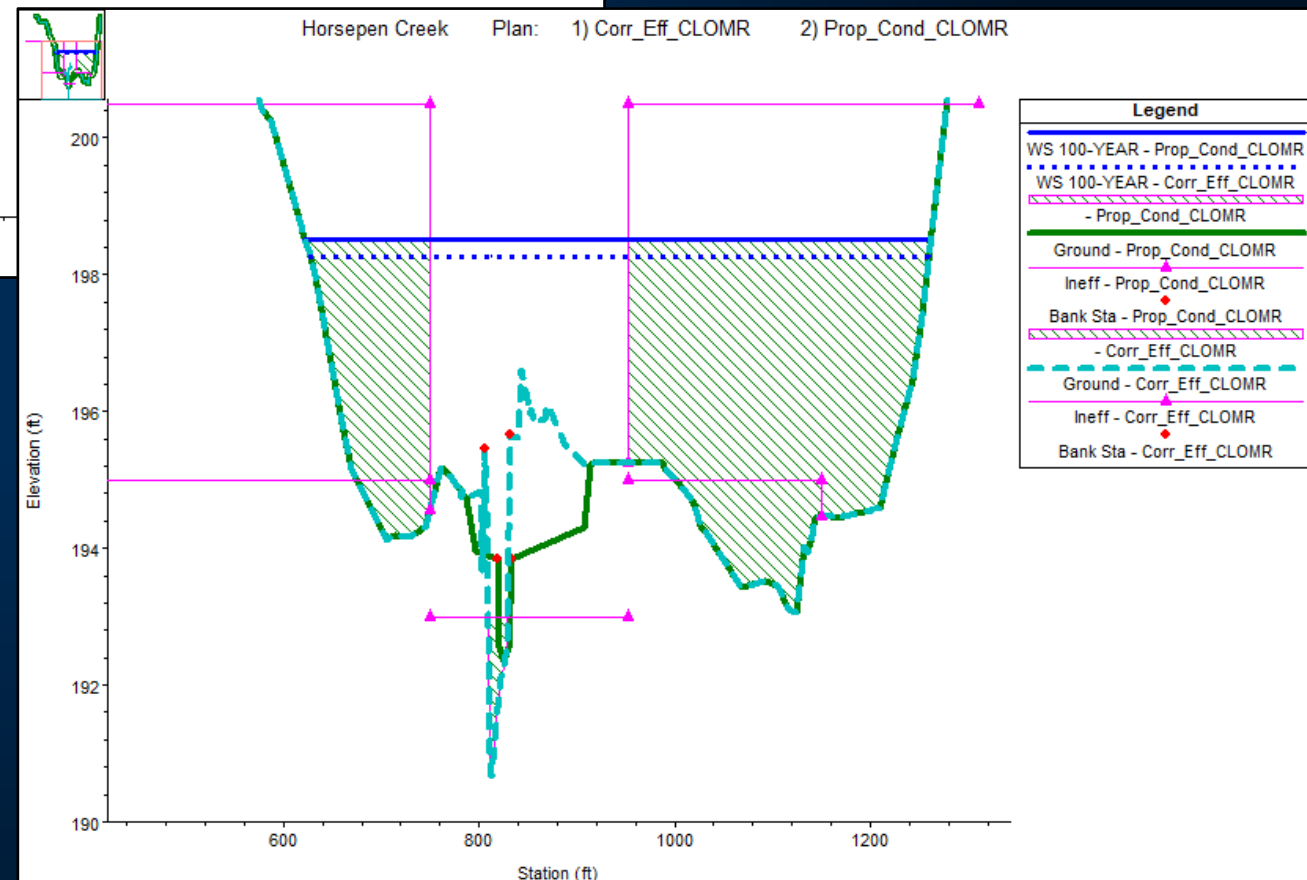
Horsepen Creek

Out of Scope Stream Grading/ Stream Assessment

0.5% Proposed Stream Grade

Modeling Driving Force

Permanent Ineffective Flow Areas

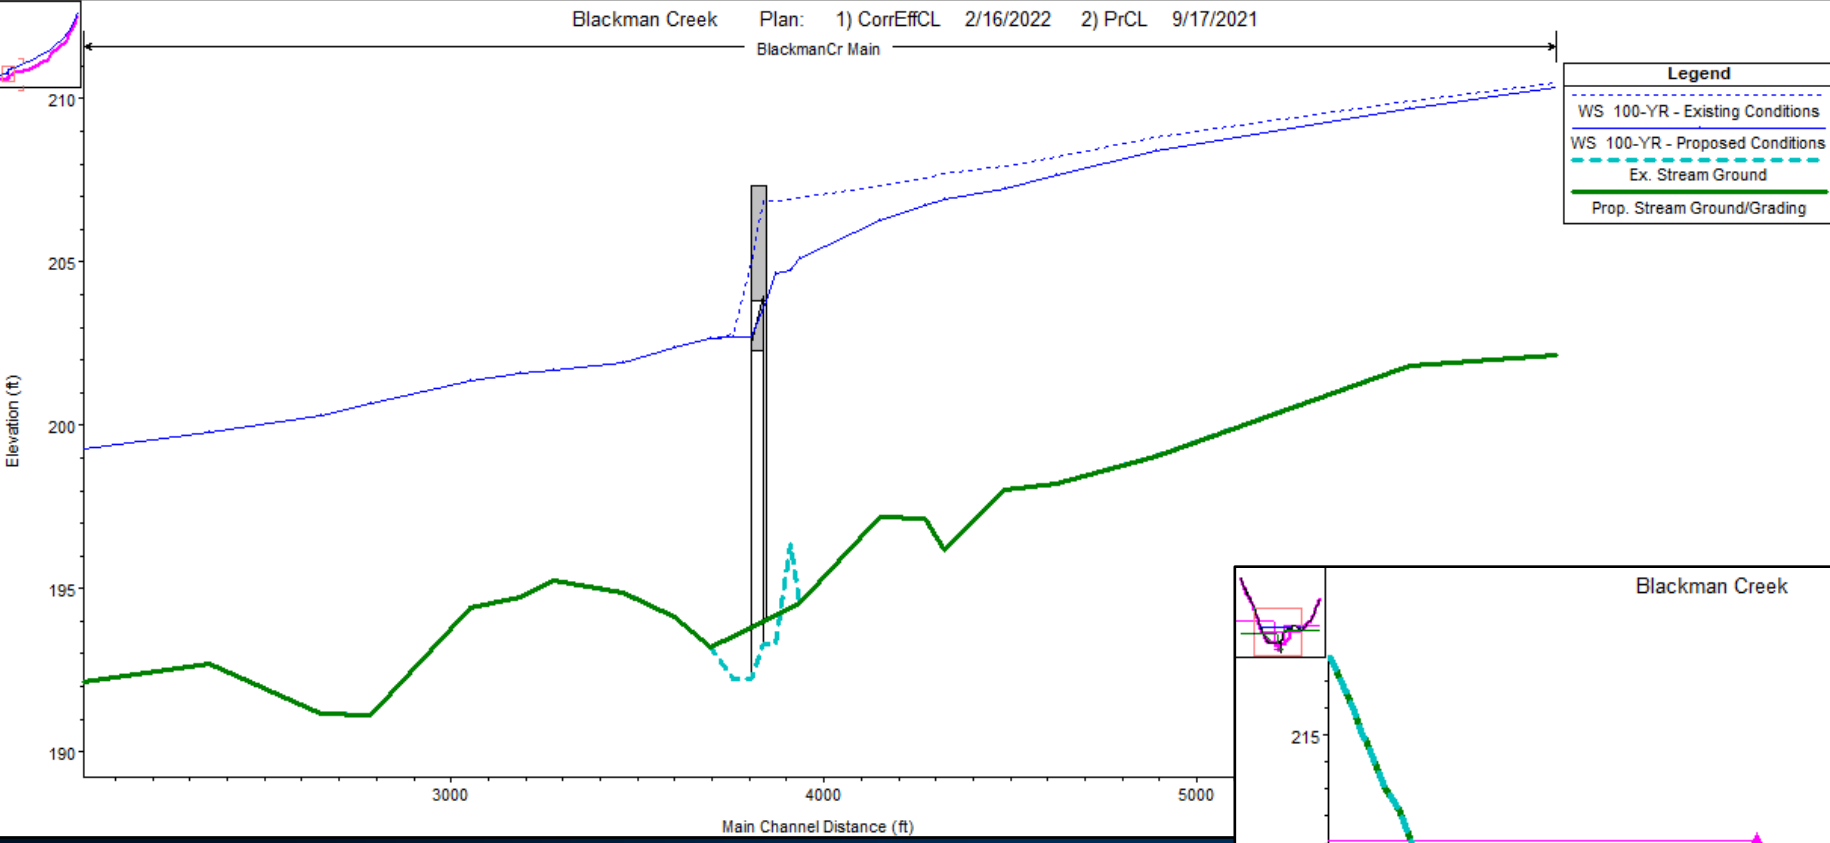
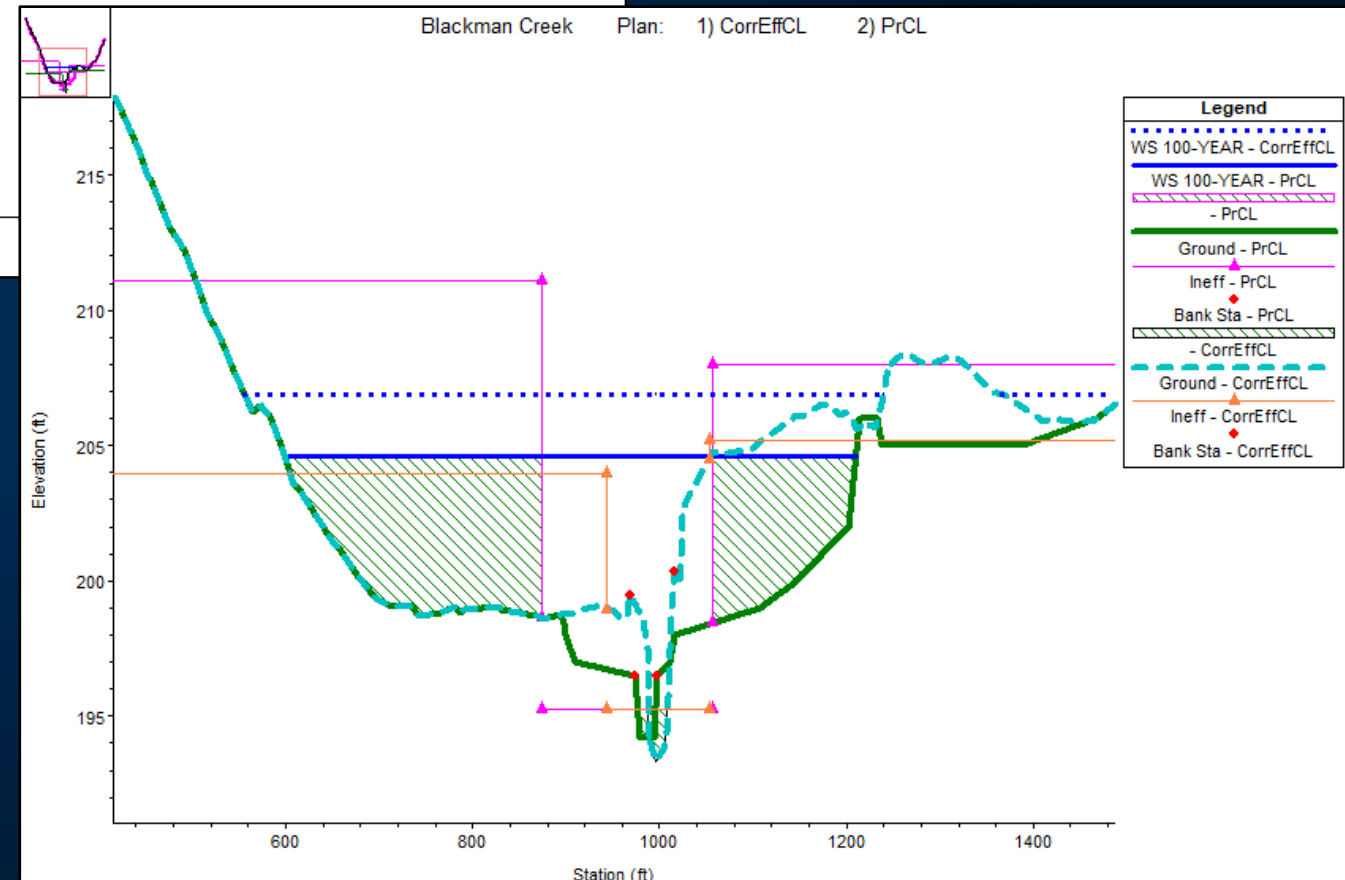
Blackman Creek

Stream grading

Scour Countermeasure Outside of Channel

Avoiding wetlands

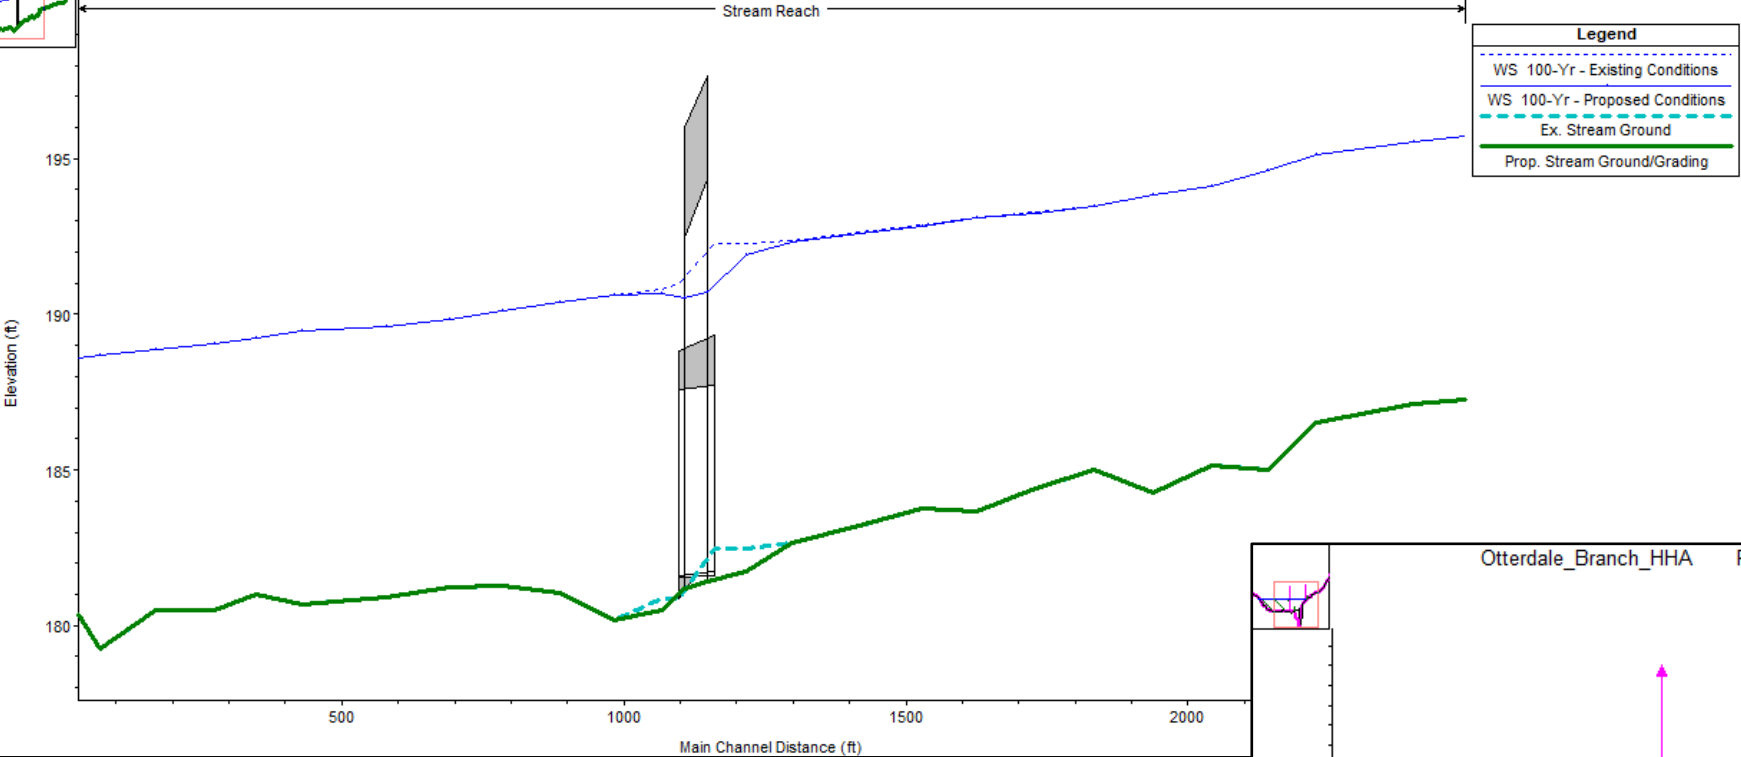
Otterdale Branch

Proposed Single Span Bridge
